LASER-INDUCED DAMAGE THRESHOLD (LIDT) MEASUREMENT REPORT

S-ON-1 (ISO 21254-2) TEST PROCEDURE

SAMPLE: SAMPLE 4

Name	Sample 4
Type	AR Coating (V coating for 1064nm)
Packaging	Wrapped in paper

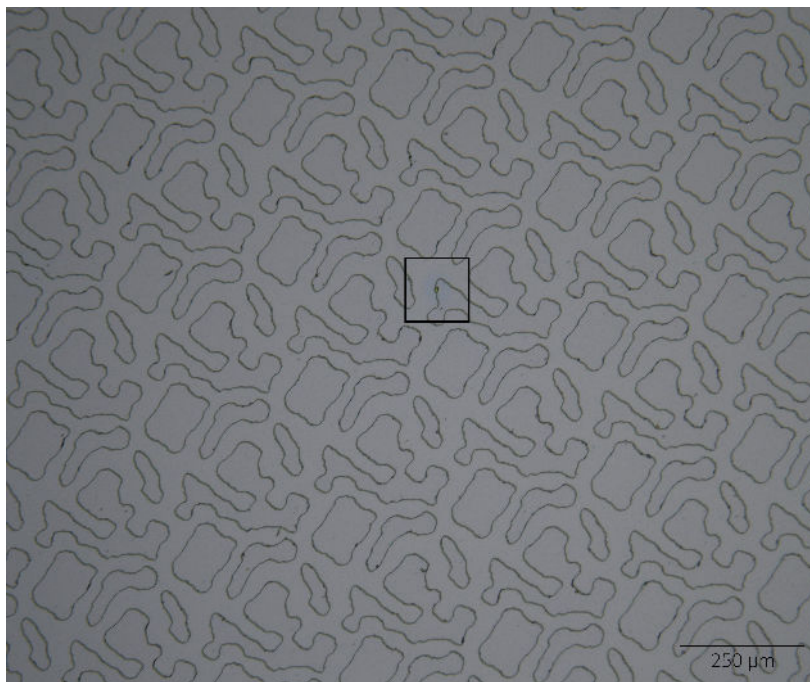
Figure 5. Typical damage morphology: fluence 28.2 J/cm², damage after 1000 pulse(s).

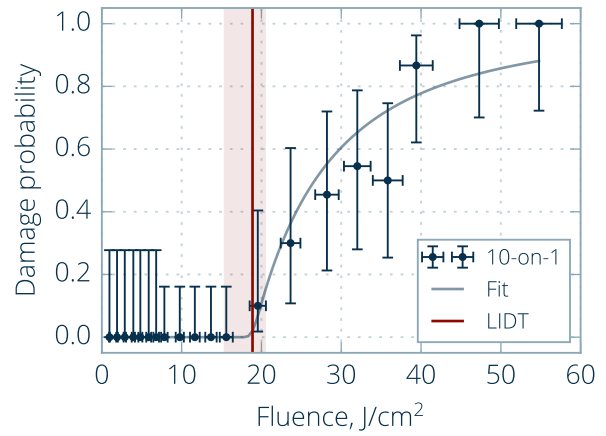
DAMAGE PROBABILITY (ONLINE DETECTION)

(a) 1-on-1

(b) 10-on-1

(c) 10²-on-1

(d) 10³-on-1

Figure 6. Damage probability plots.
